# Zero-Fouling operation in Condensers Cooled with Hard Well Water in a Dairy Plant

**Industry:** Dairy (food)  
**Application:** Hard Well Water Condenser  
**Product:** Self-cleaning Condenser  
**Location:** USA  
**Year of Installation:** 1988  
**Additional Purchase:** 2023

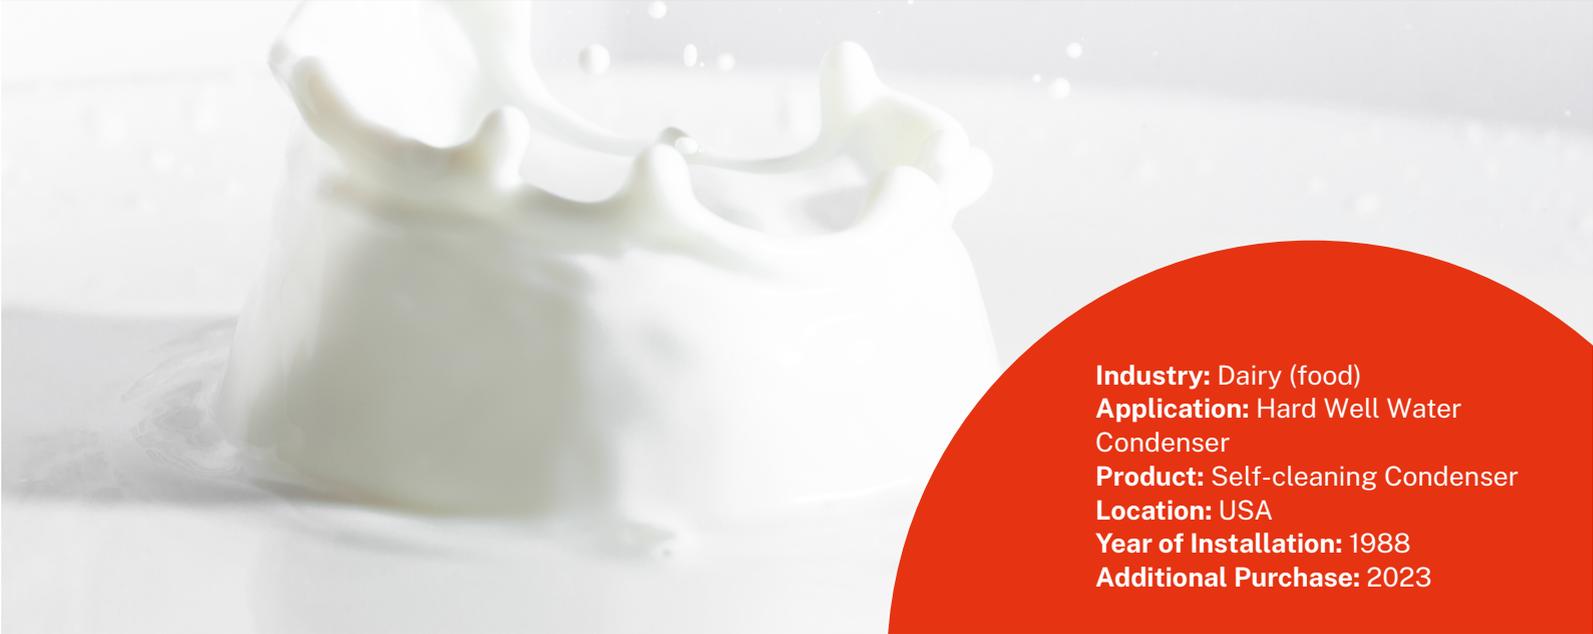
Self-cleaning Condenser

<b>Parameters</b>			<b>Condenser</b>			
		I	II	III			
	<b>Tube Side</b>	Hard Well Water					
	<b>Shell Side</b>	Vapor					
	<b>Number of Tubes</b>	7	19	19			
	<b>OD/ID Tubes (mm)</b>	51 x 1.5		60.3 x 1.5			
	<b>Length Tubes (m)</b>	6					
	<b>Heat Transfer Area (m<sup>2</sup>)</b>	6	18	21			
<b>Particle Size (mm)</b>	3

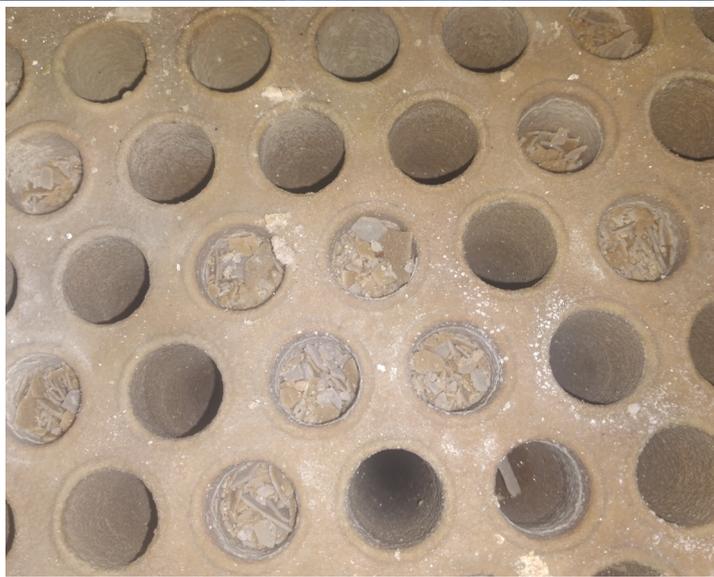
**Conventional**

Fouling has never been observed, contrary to earlier experiences with conventional exchangers that required a lot of maintenance on a regular basis.

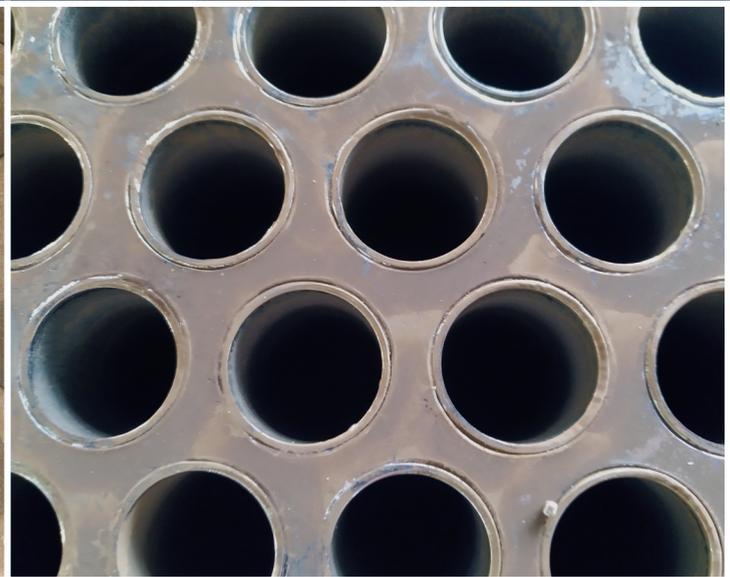
**Self-cleaning**

All three exchangers went into operation without any problems and were only opened once to twice a year for inspection. The units operate 85% of the time and are still running (as of 2023 from 1988) to the satisfaction of the customer.

*“Statement made by the plant director inspecting the tubes after 3 years of operation without being subjected during that period to any cleaning procedure: “... how is this possible, ... these tubes look better than new...”*
